3 WEST OF US 83 NORTH

IDENTIFICATION	
(1) State Names	North Dakota
(8) Structure Number	0094-156.609
(5) Inventory Route	00094
(2) Highway Agency District	61
(3) County Code	Morton, North Dakota

(4) Place Code	7200
(6) Features Intersected	MISSOURI RIVER
(7) Facility Carried	INTERSTATE 94
(9) Location	3 WEST OF US 83 NORTH
(11) Mile Point	156.576 mi

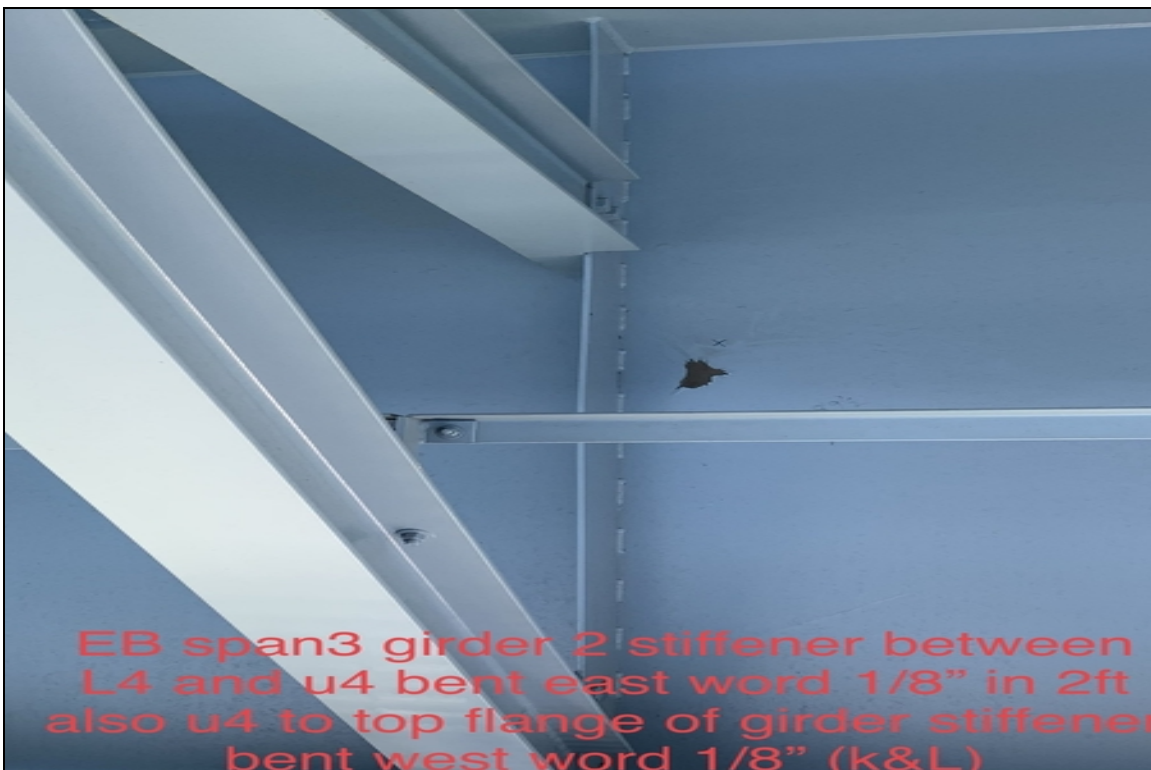
EB span 3 girder 2 stiffener between L4 and U4 bent east word 1/8" in 2 ft also U4 to top flange of girder2 stiffener bent west word 1/8" (K&L)

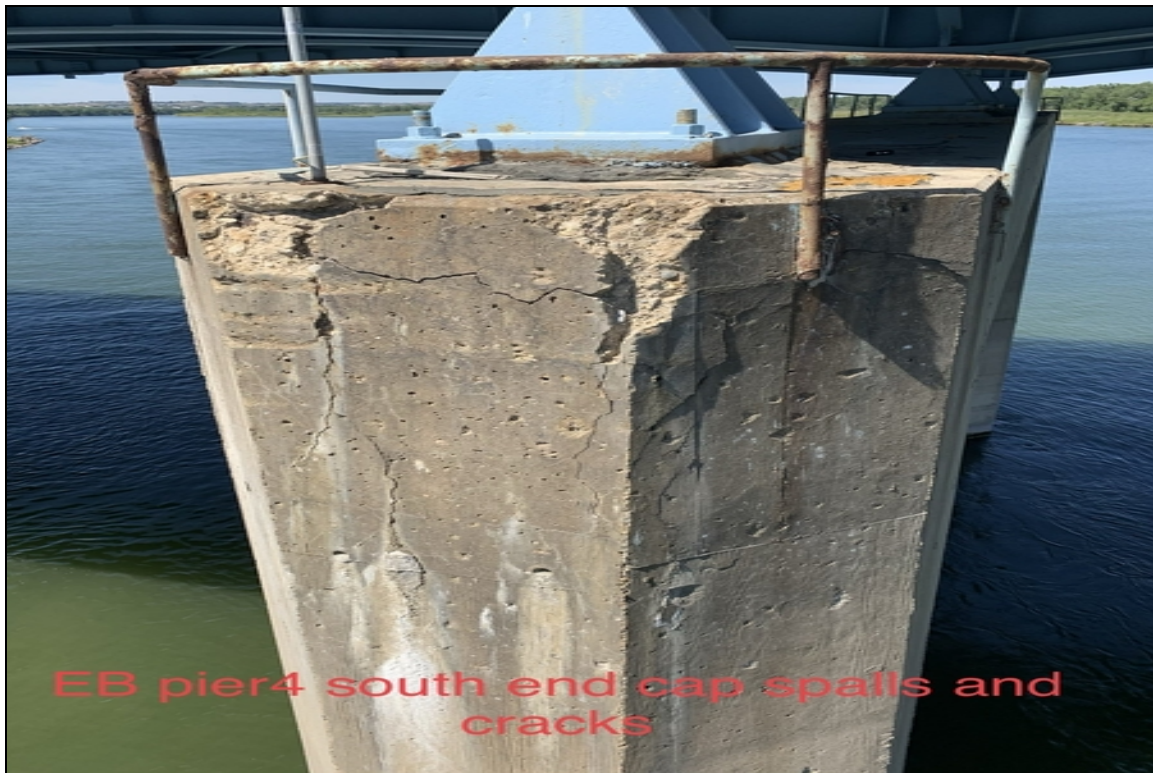
EB pier 4 south end cap spalls and cracks

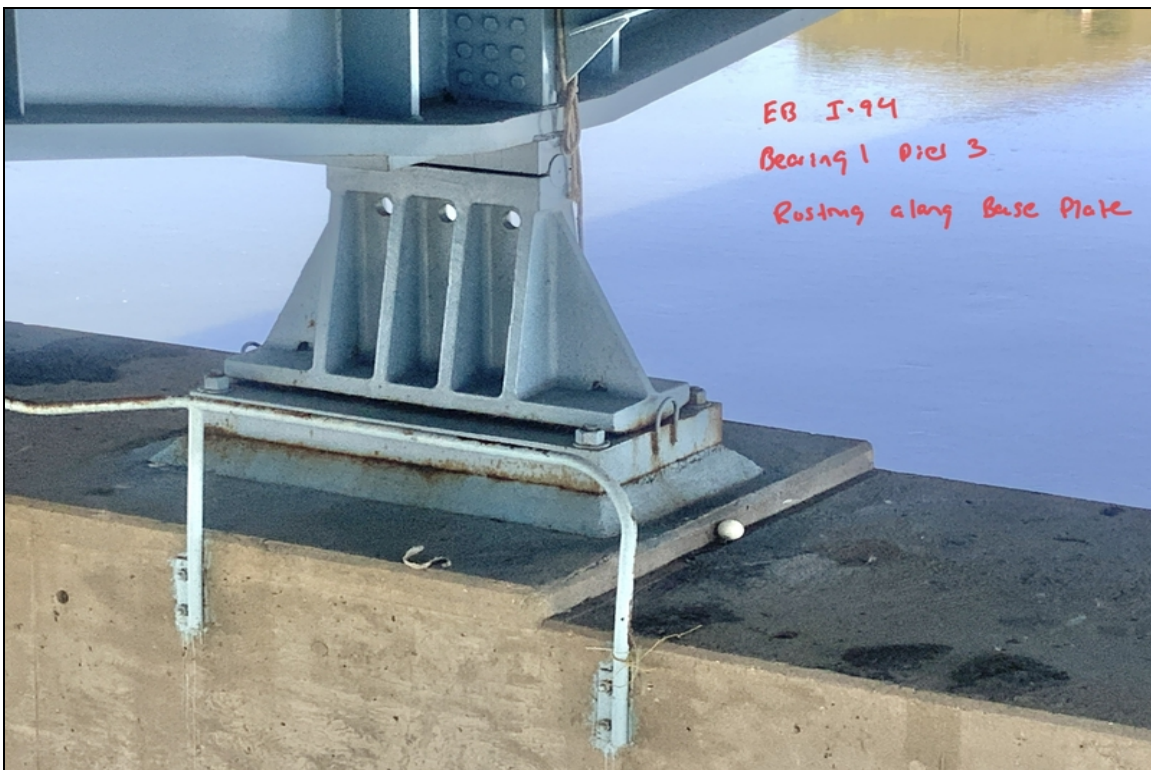
Facing NE. Rusting along baseplate to EB I-94 Bearing 1 at Pier 3.

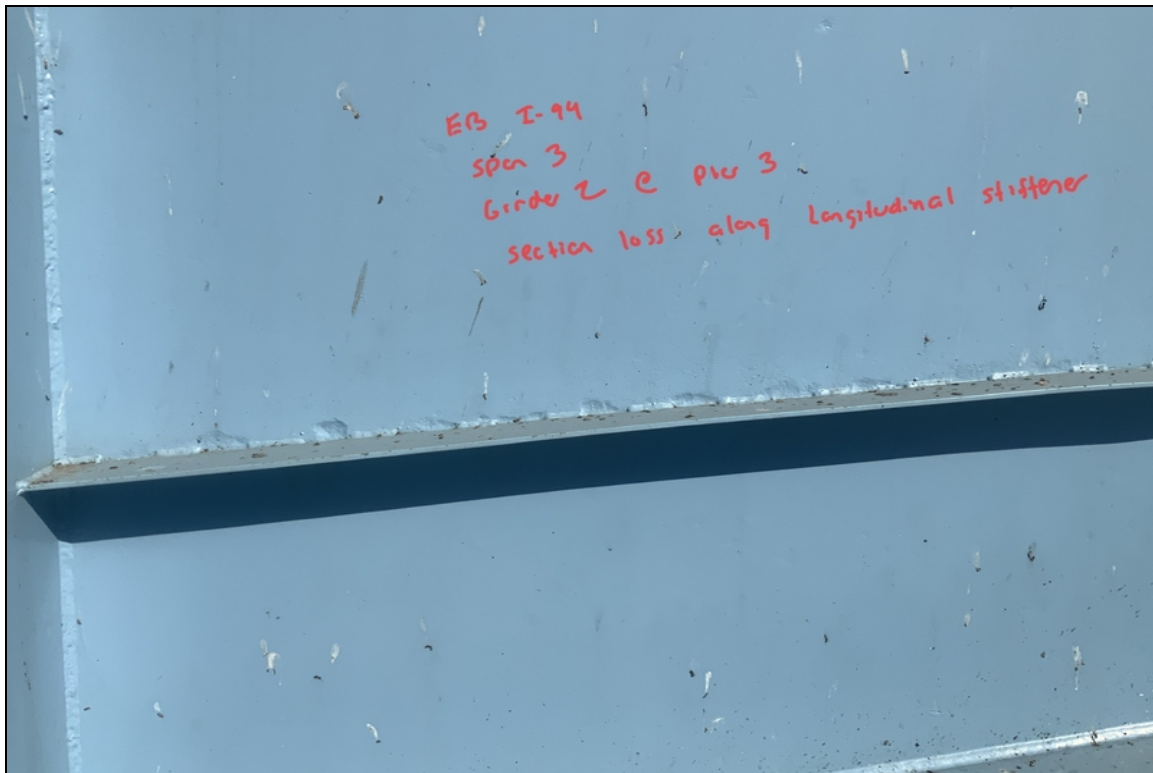
8/17/2020 - Section Loss along EB I-94 Girder 2 south Web along toe to bottom flange. Areas are various and throughout Girder 2. Areas of Section Loss to South Web above Longitudinal Stiffeners throughout most spans. Two Indents in-between Diaphragms 8 and 9 of Girder 2 in Span 3 South Facia with areas 6" by 5/8" D and 1' x 5/8" D

Facing North. Section Loss to EB I-94 Girder 2 South Web above Longitudinal Stiffener.

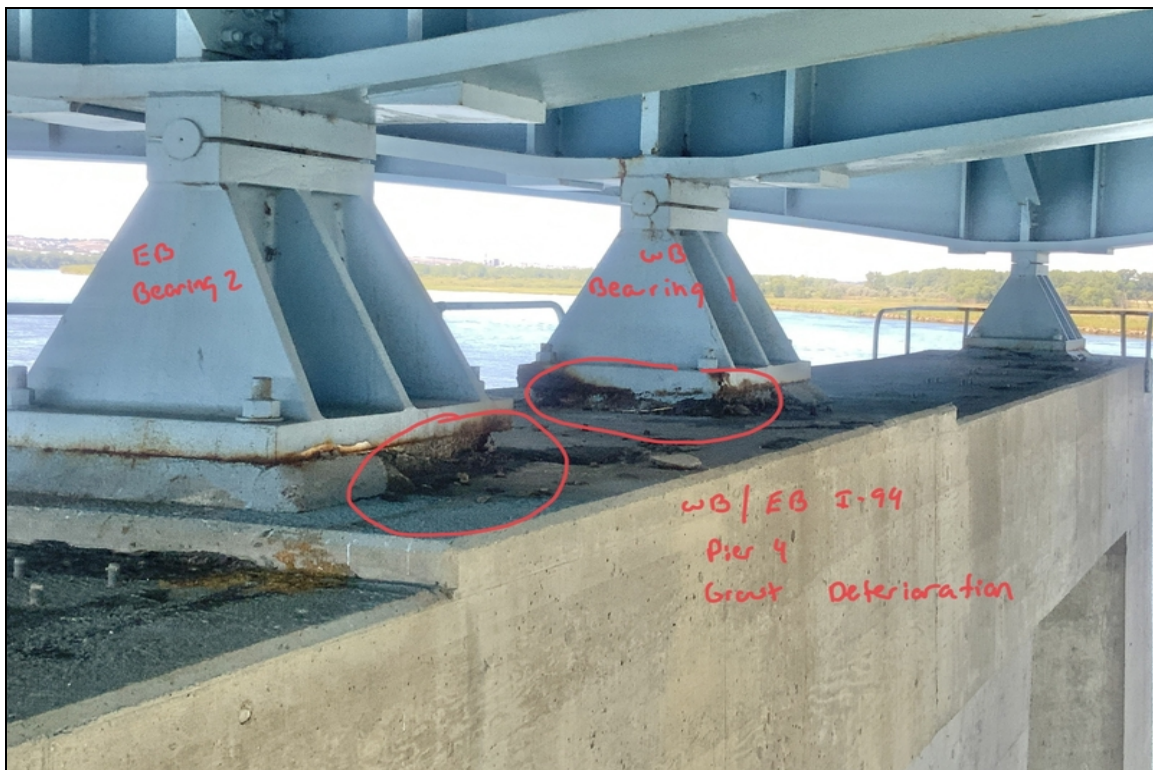
Facing NE. Deterioration of Grout Seal around Bearing 2 WB I-94 and Bearing 1 EB I-94.

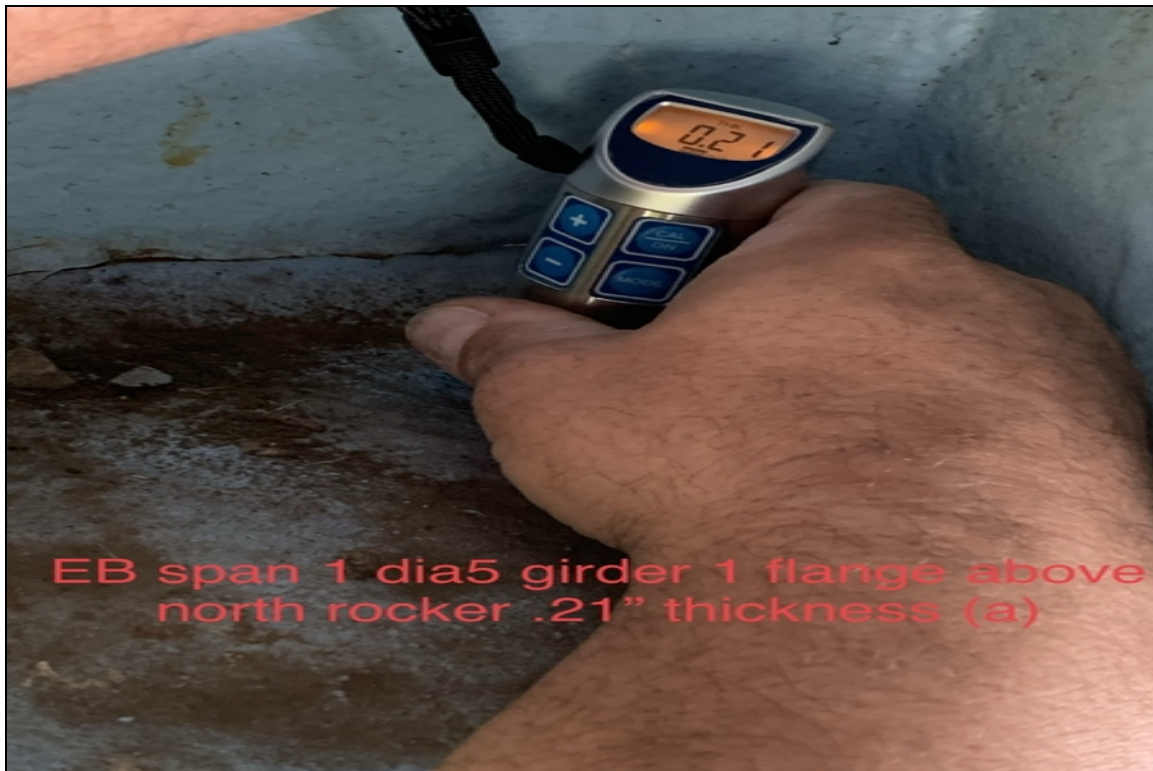
EB span 1 dia 5 girder 1 flange above north rocker .21" thickness (A)

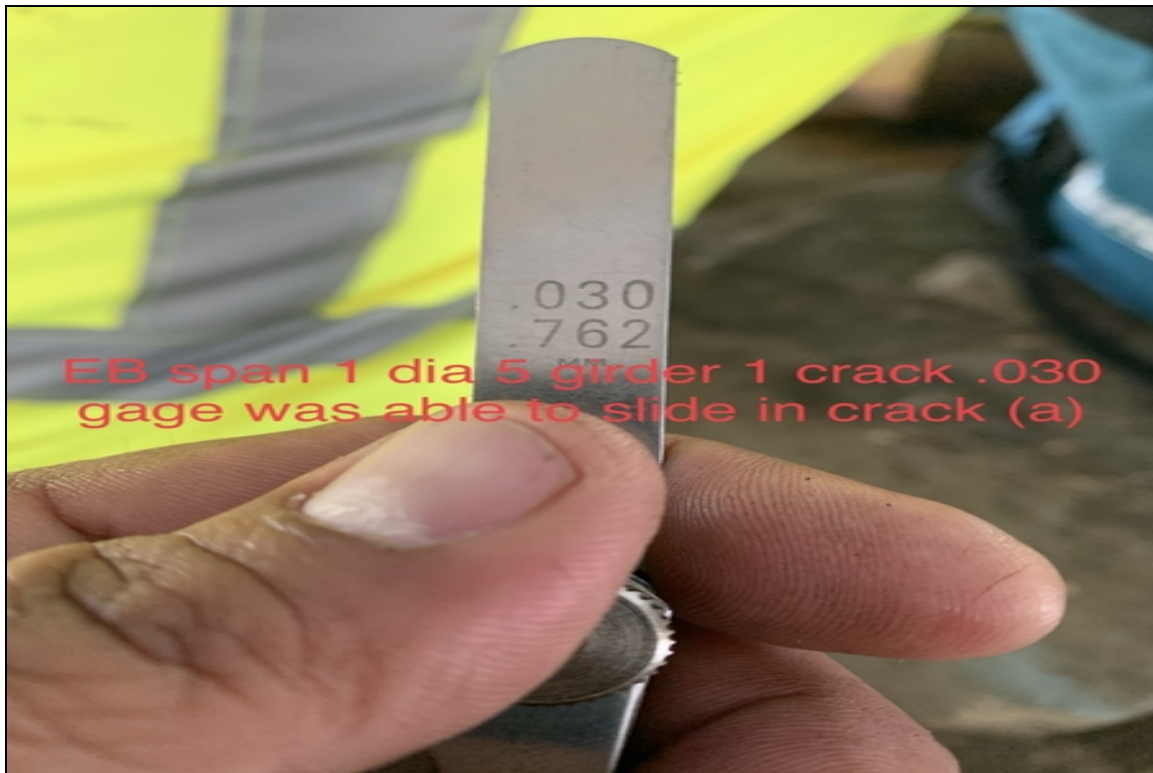
EB span 1 dia 5 girder 1 crack .030 gage was able to slide in crack (A)

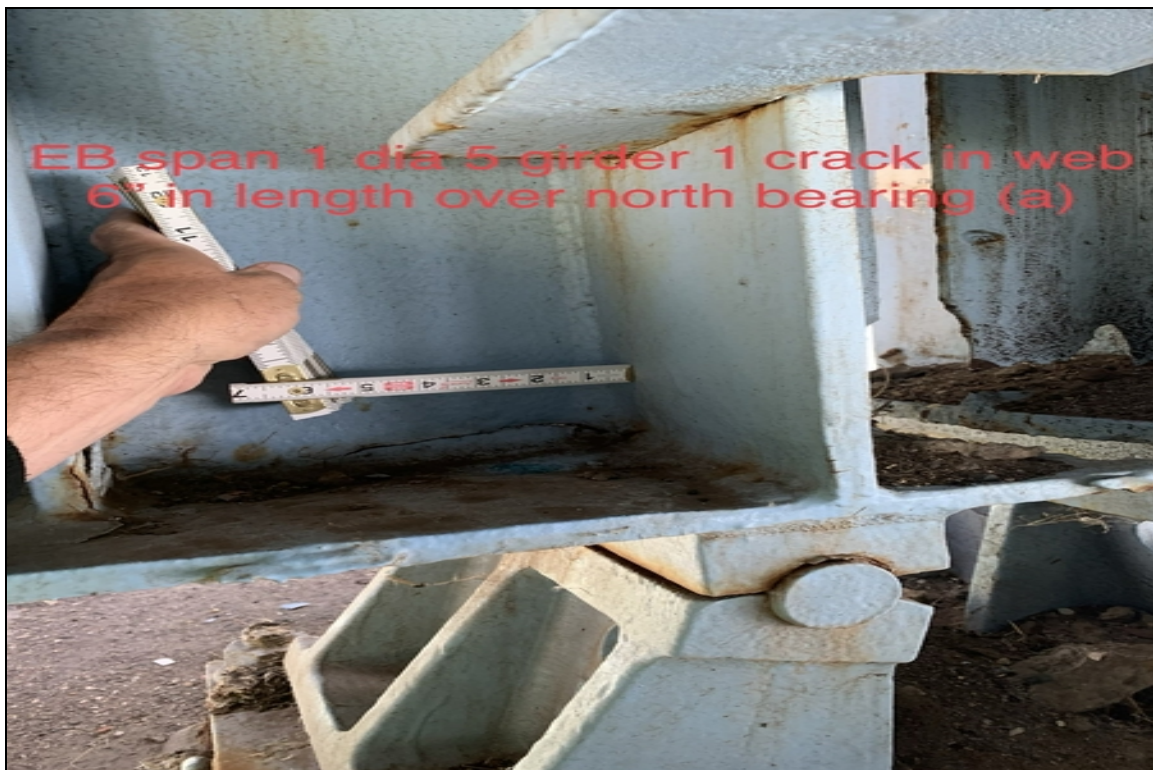
EB span 1 dia 5 girder 1 crack in web 6" in length over north bearing (A)

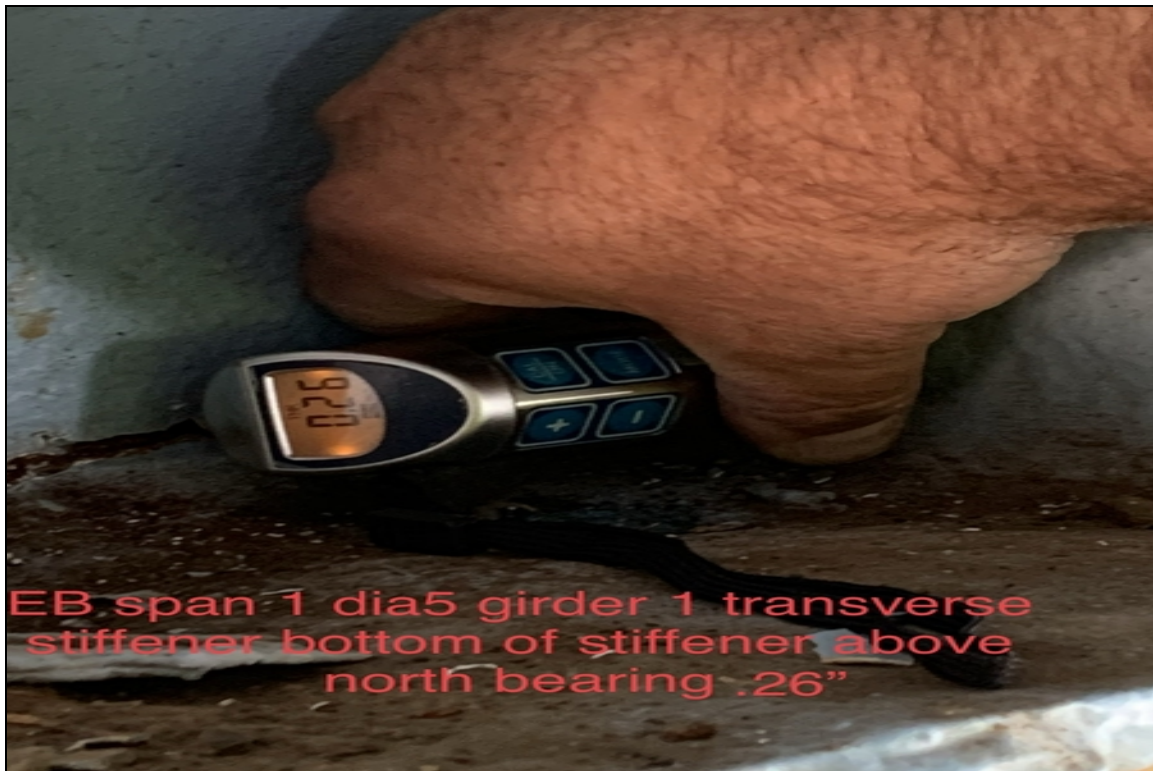
EB span 1 dia 5 girder 1 transverse stiffener, thickness check at the bottom of stiffener above north bearing .26" thickness (A)

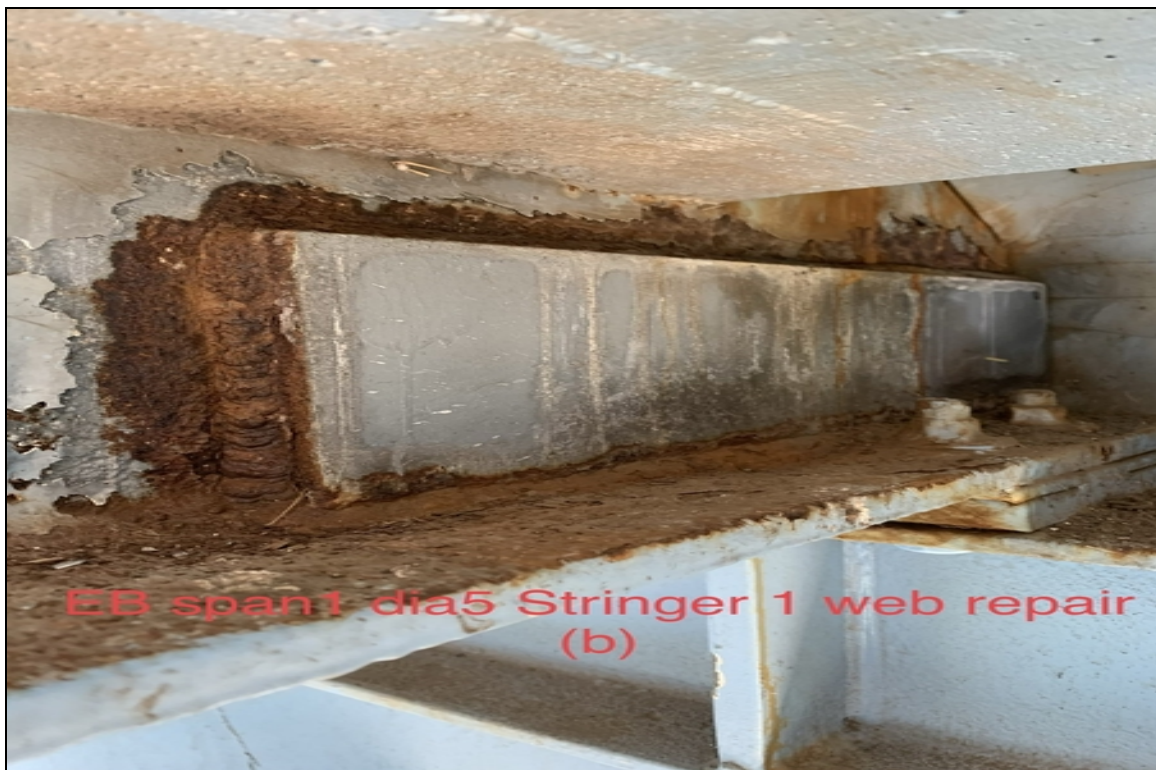
EB span 1 dia 5 stinger 1 web repair (B)

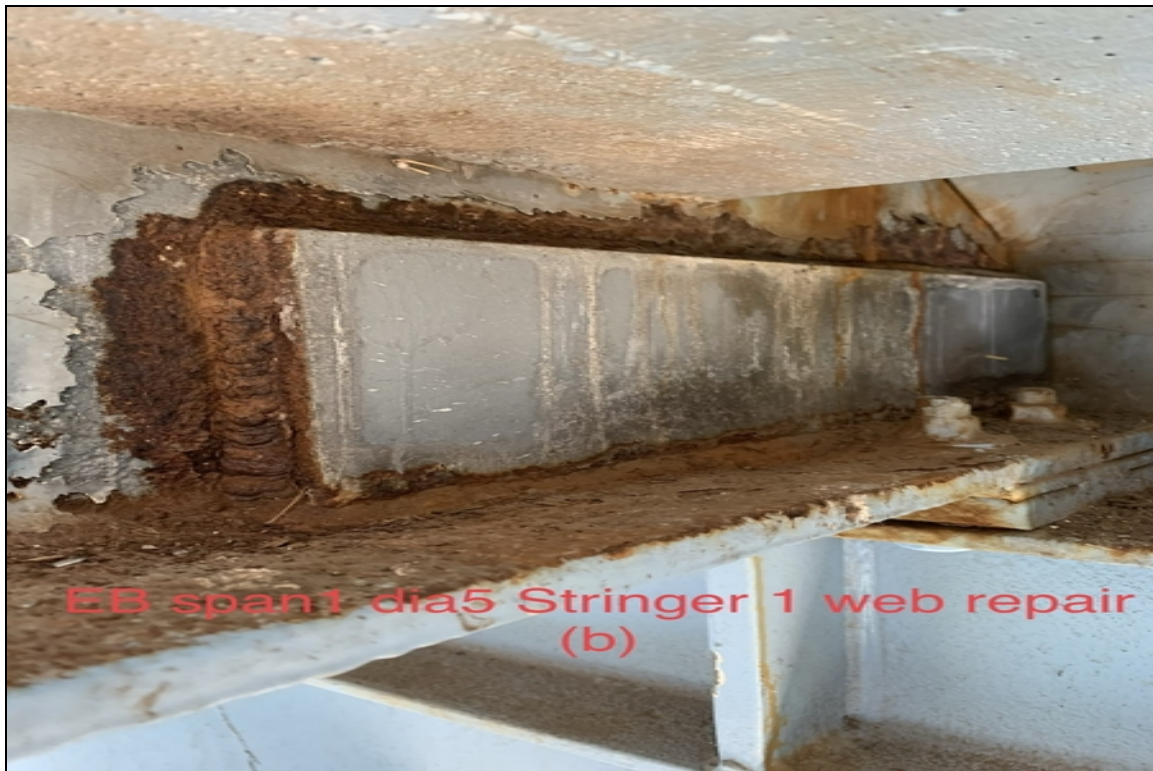
EB span 1 dia 5 stinger 1 web repair (B)

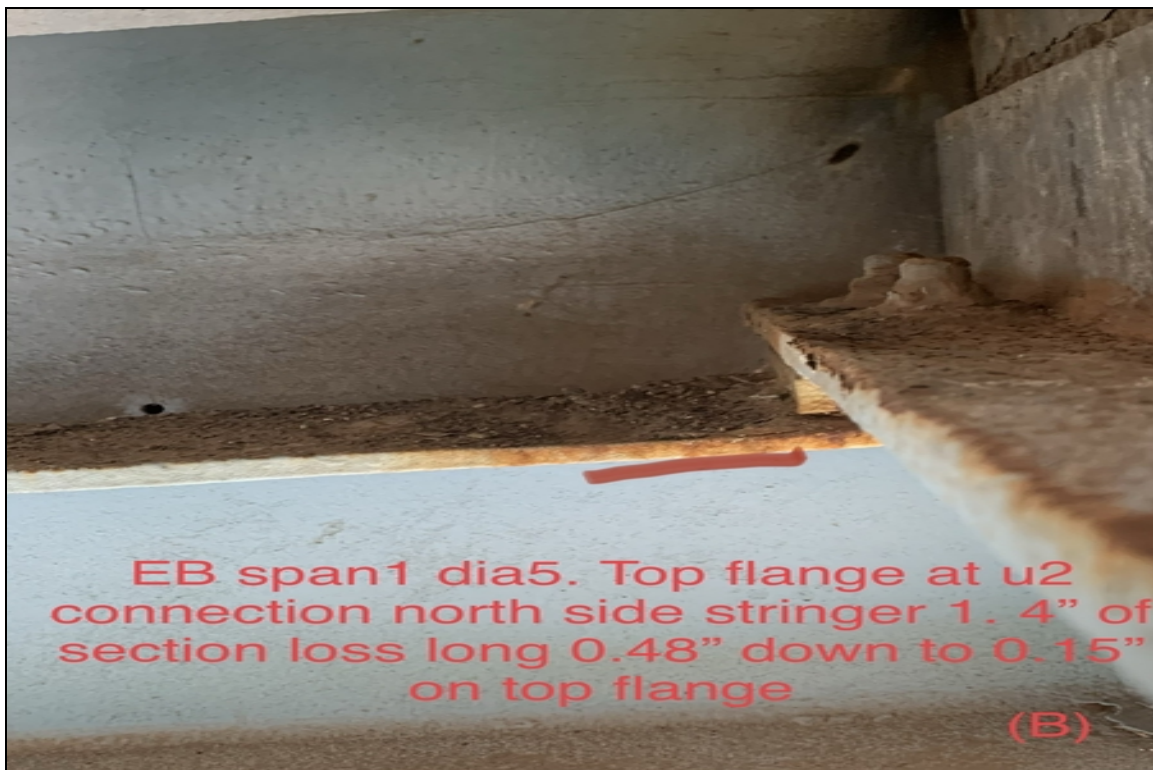
EB span 1 dia 5 top flange at U2 connection north side stringer 1. 4" of section loss long 0.48" down to 0.15" on top flange

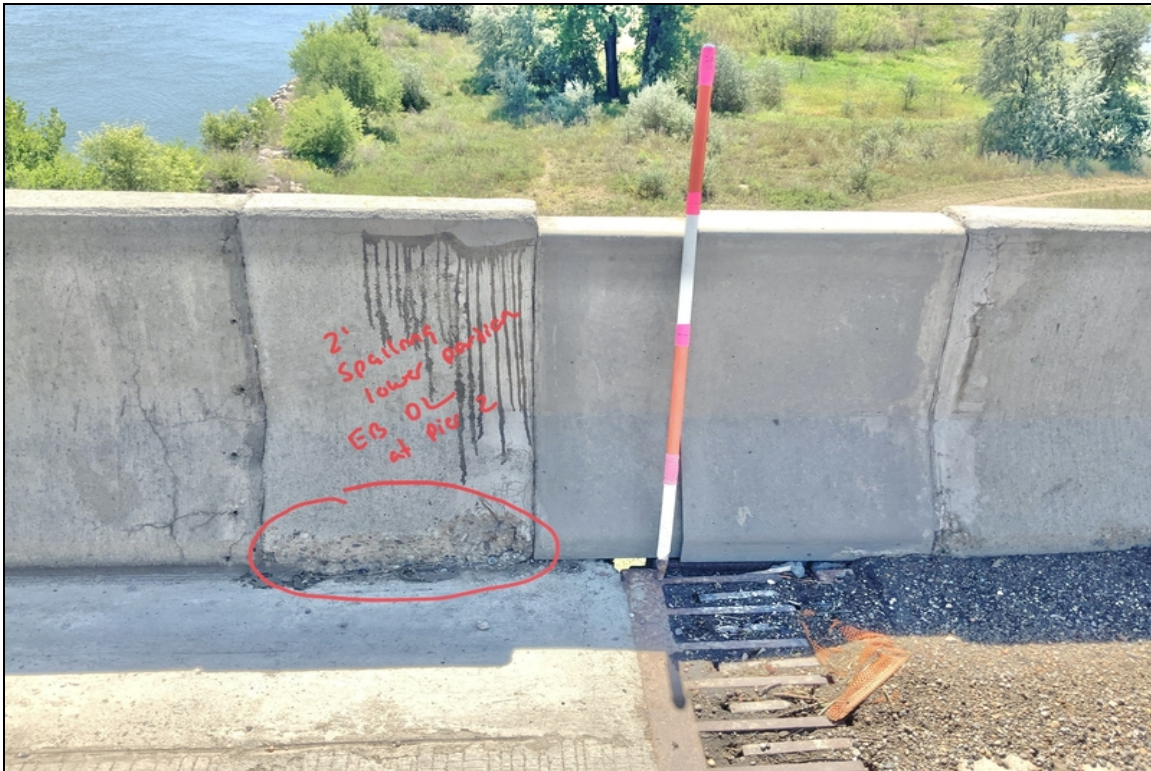
Facing South. Spalling along lower portion of South Barrier at Pier 2 Expansion Joint.

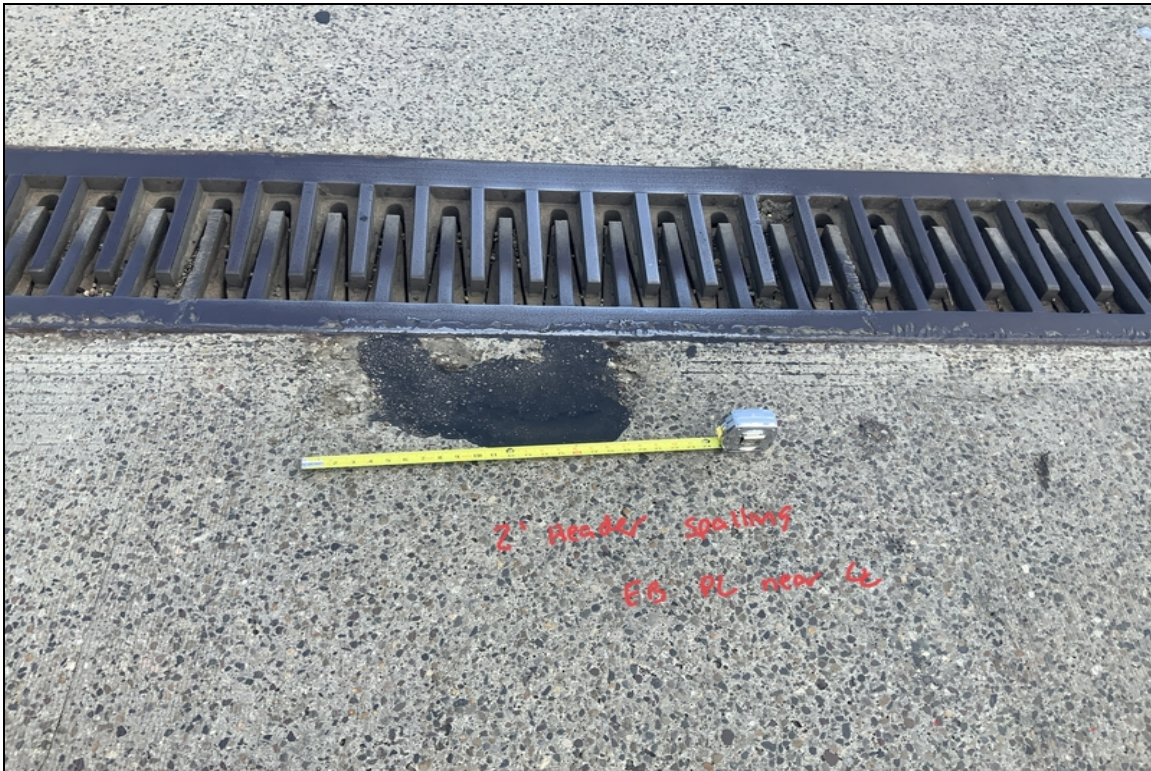
Facing East and Downward. Header Spalling to EB DL near CL across Pier 2 Expansion Joint.

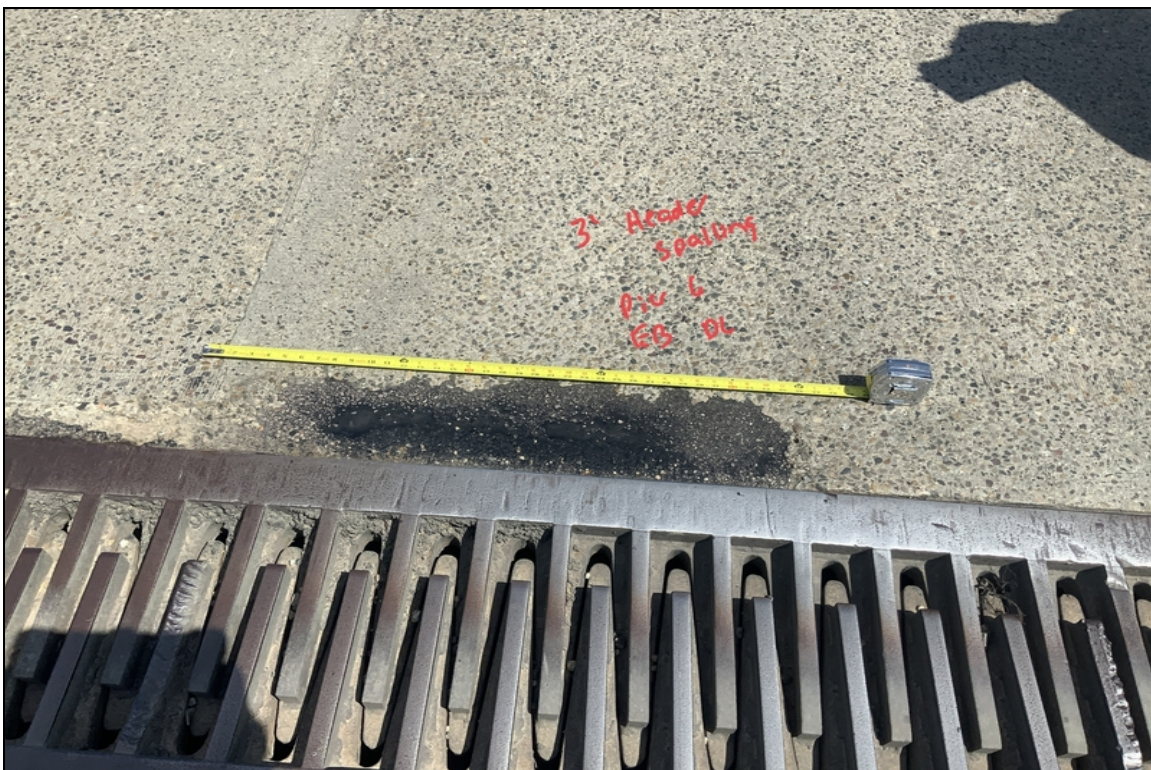
Facing East and Downward. Header Spalling along Pier 6 Expansion joint EB DL.

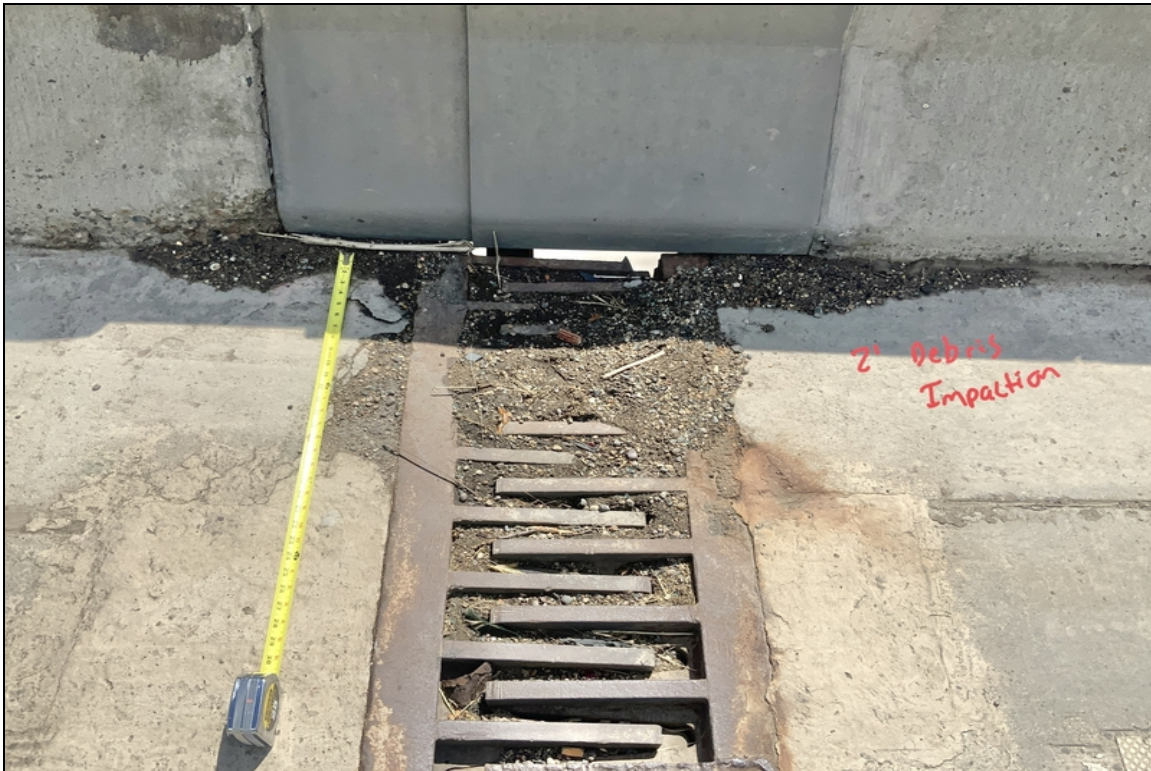
Facing South and Downward. Debris Impaction to EB L Deck Extension Gutter Line.

Recommendation to flush Gutter Lines. Pier 2 and Pier 6 with debris filling up in both Expansion Joints. Recommendation to Flush out the Joints. Recommendation to clean out drainage systems. Sediment and Aggregate Buildup along WB and EB DL Gutter Lines.

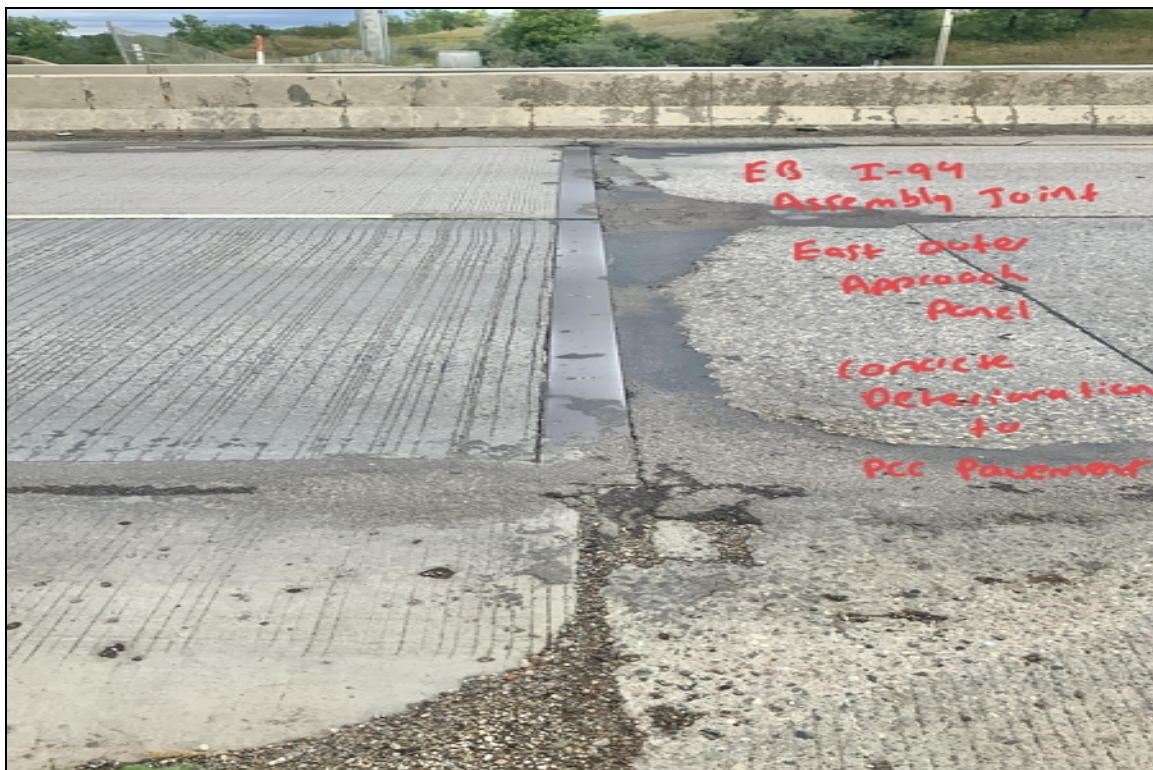
Facing North. EB Approach and Outer Approach Transverse Joint with spalling across PCC Pavement causing Impaction to movement. Majority filled in with HMA or Debris.

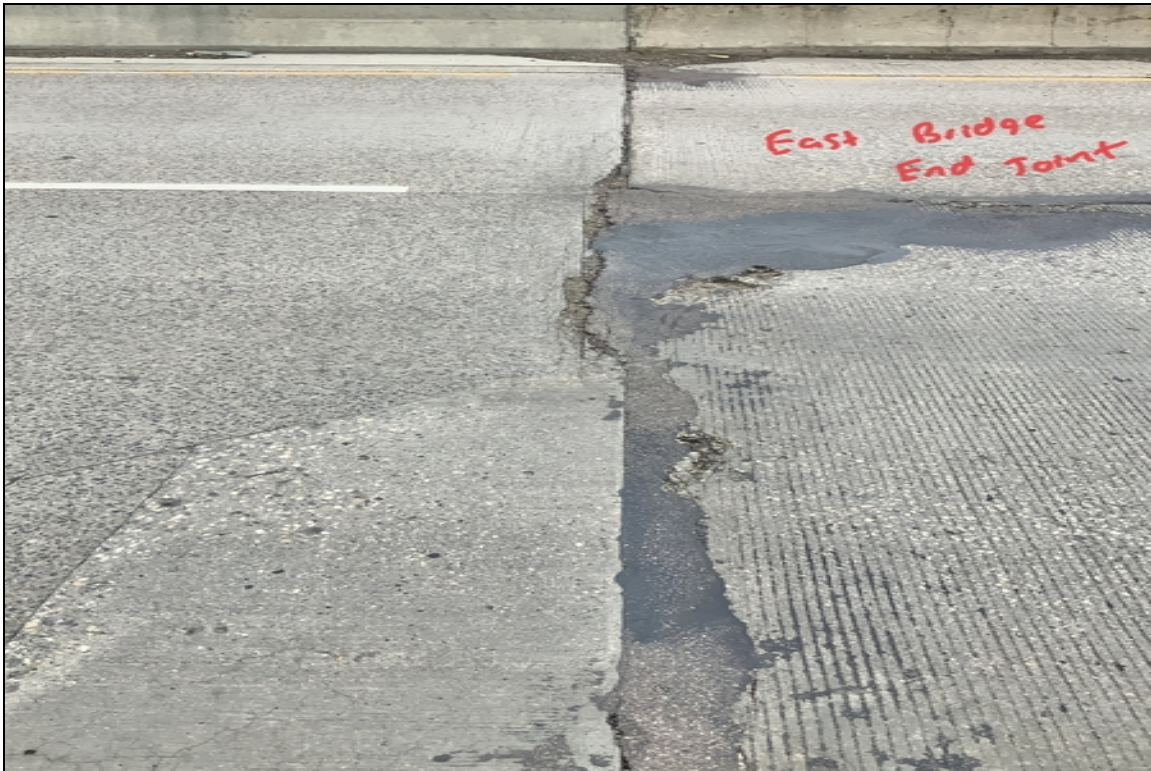
Facing North. EB I-94 East End Bridge Joint. Seal Joint Failure.

Recommendation to Clean and reseal joints.

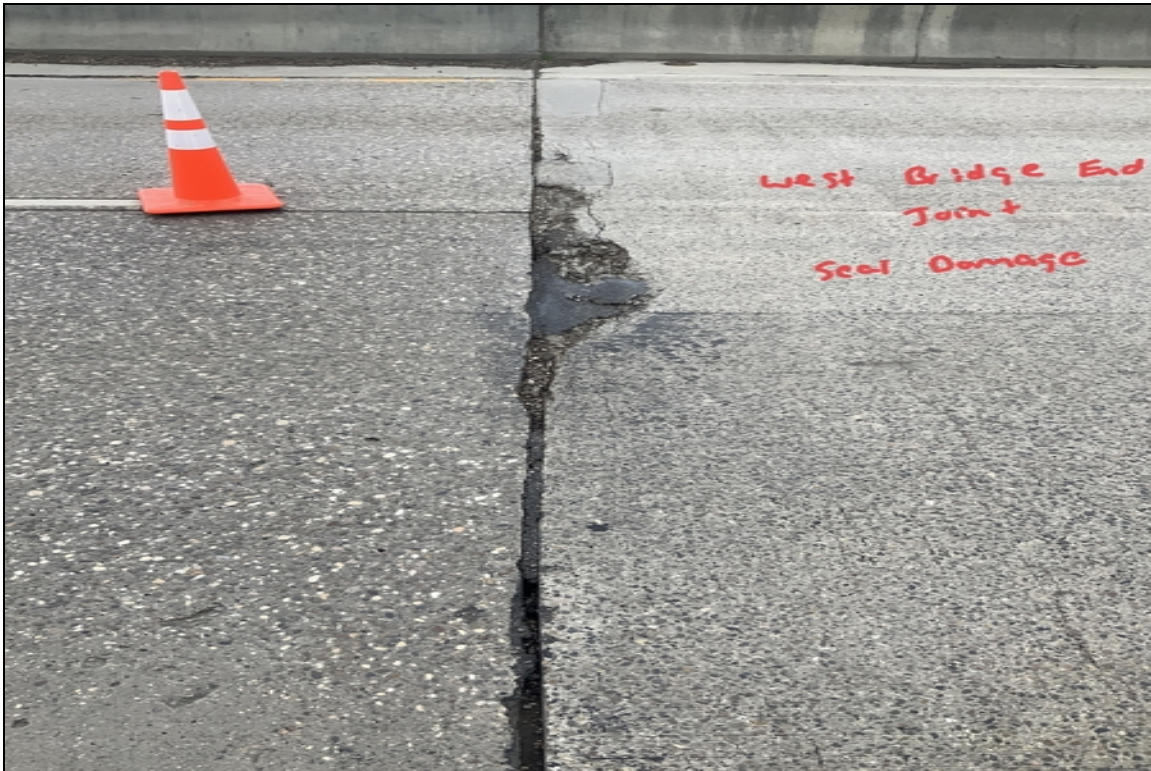
Facing North and Downward. EB I-94 West End Bridge Joint with Seal Damage

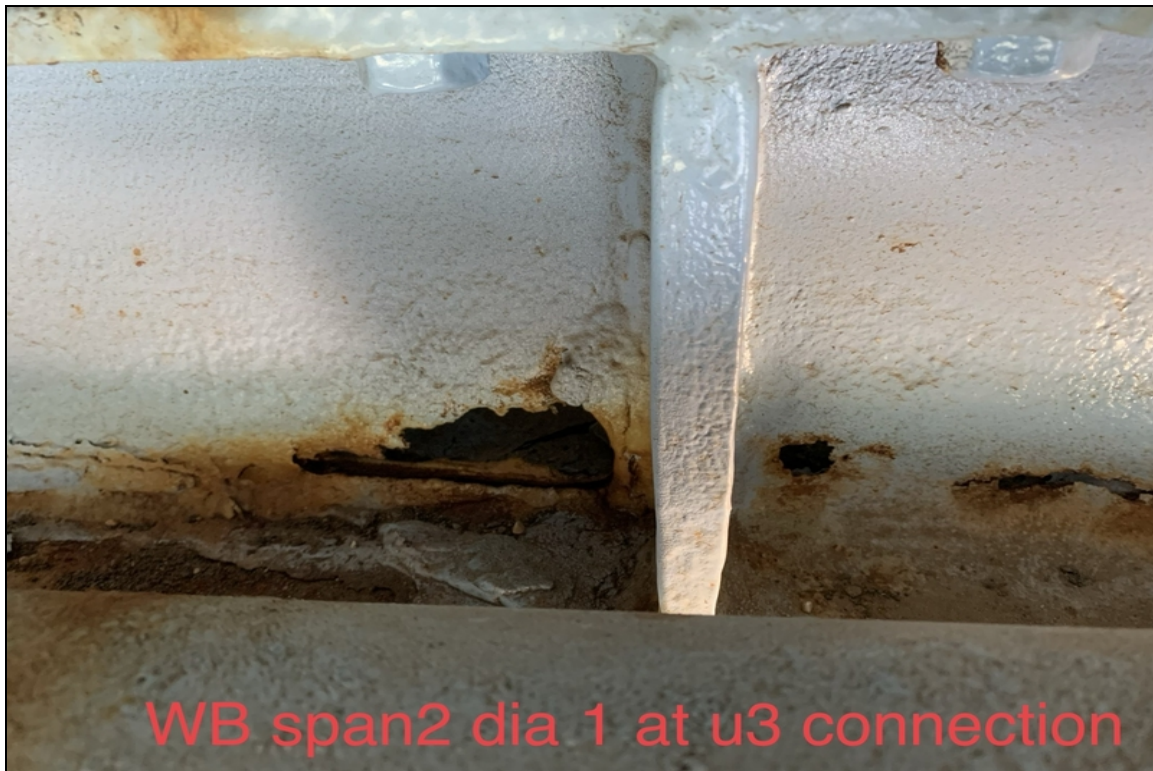
WB span 2 diaphragm 1 u3 connection upper chord rotted thru Fracture critical member and also 2 holes on the non fracture critical member

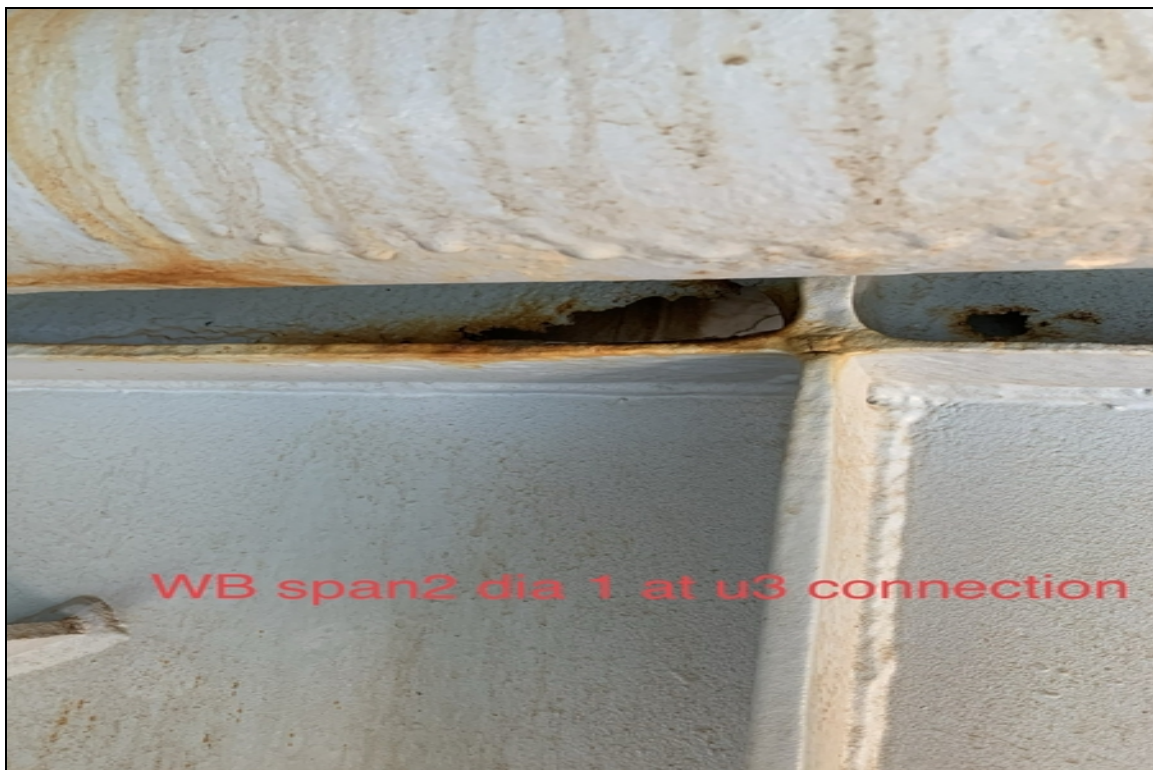
WB span 2 diaphragm 1 at u3 connection rotted web

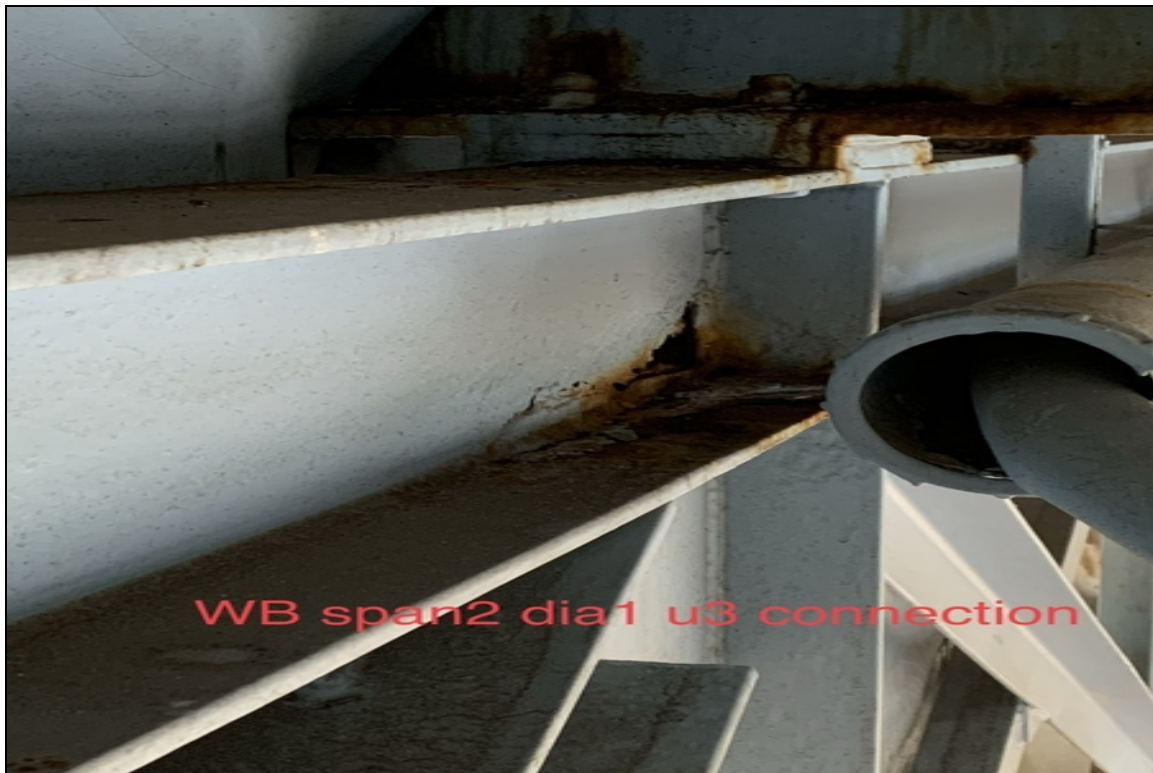
WB span 2 diaphragm 1 u3 connection fracture critical member rotted web

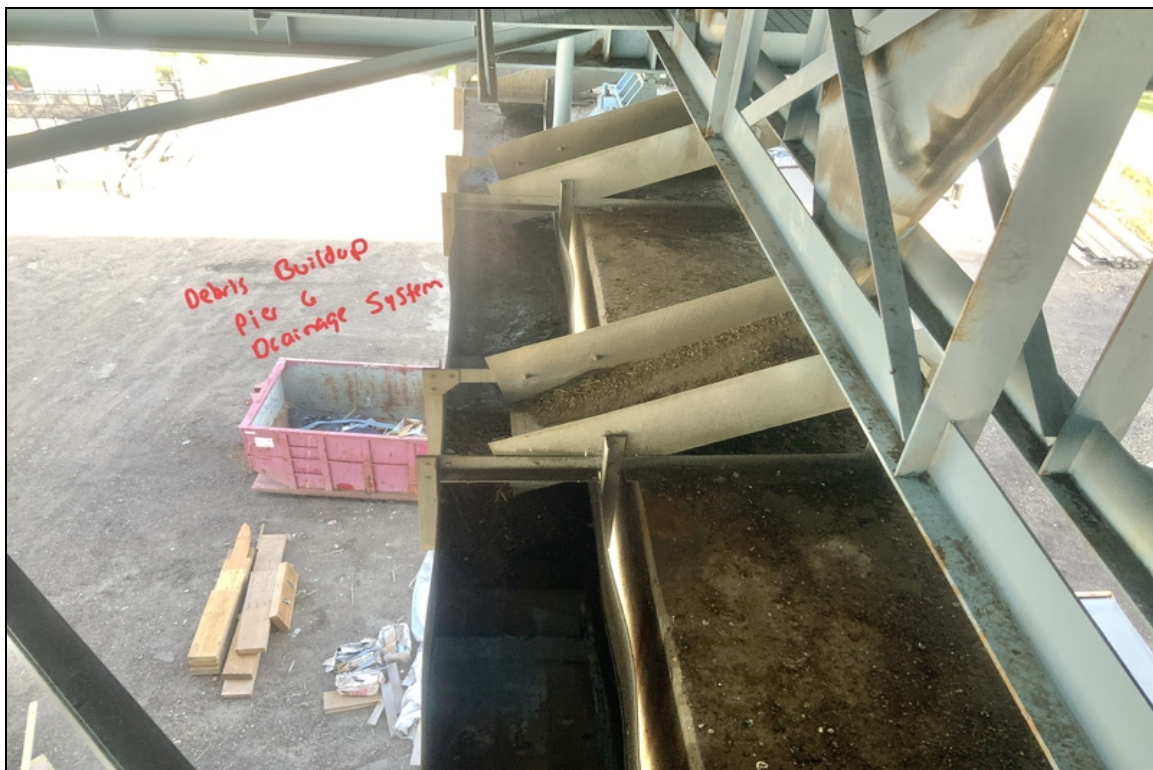
Facing North and Downward. General View of Pier 6 drainage system with sediment and debris buildup restricting flow.

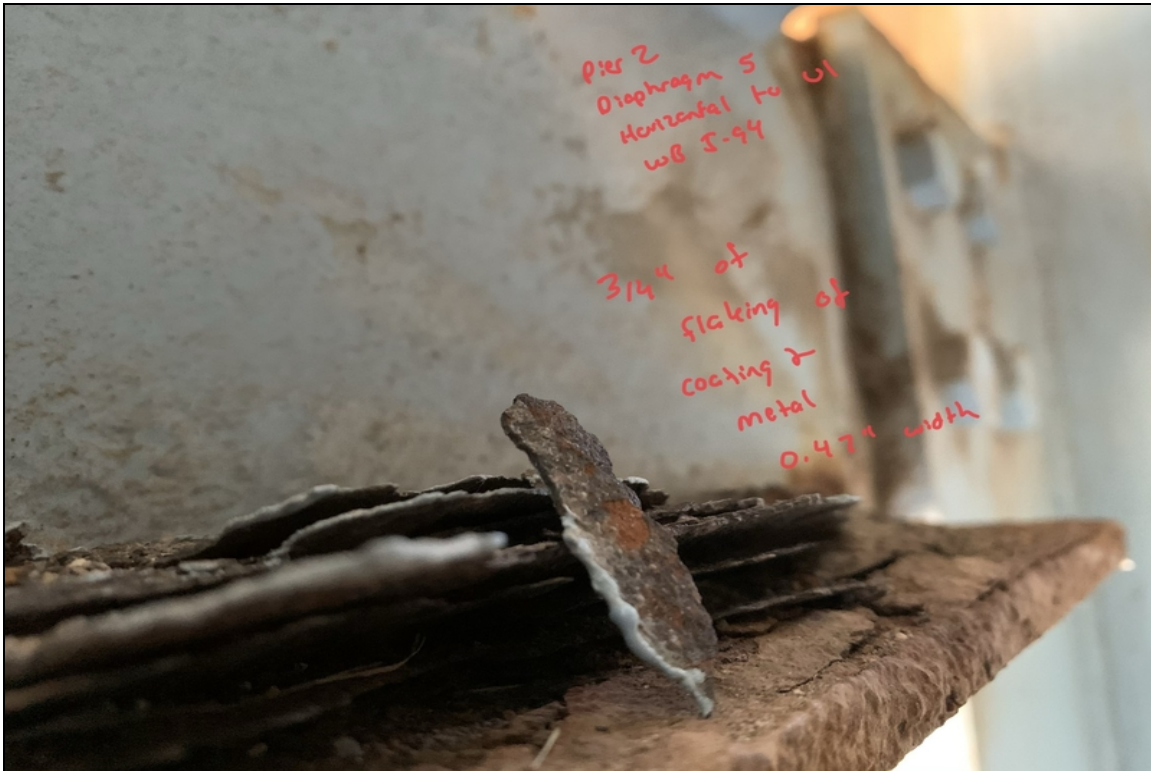
Facing North. WB I-94 Pier 2 Diaphragm 5 U1-U2 Horizontal with pack rust and peeling of coating and steel to bottom flange near U1-L1.

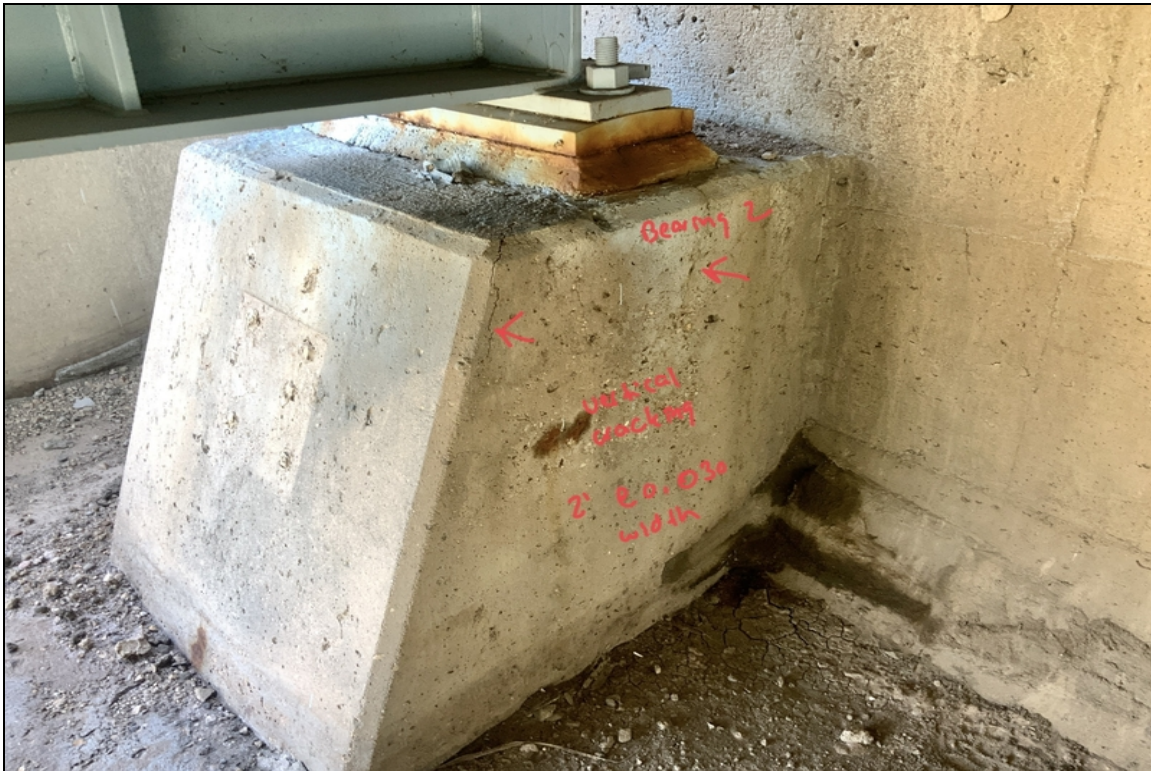
Facing SW. Vertical Cracking to EB I-94 Bearing 2 at West Abutment.
